# **Coal Mine Bumps: Five Case Studies in the Eastern United States**

By Alan A. Campoli, Carla A. Kertis, and Claude A. Goode

**Information Circular 9149**

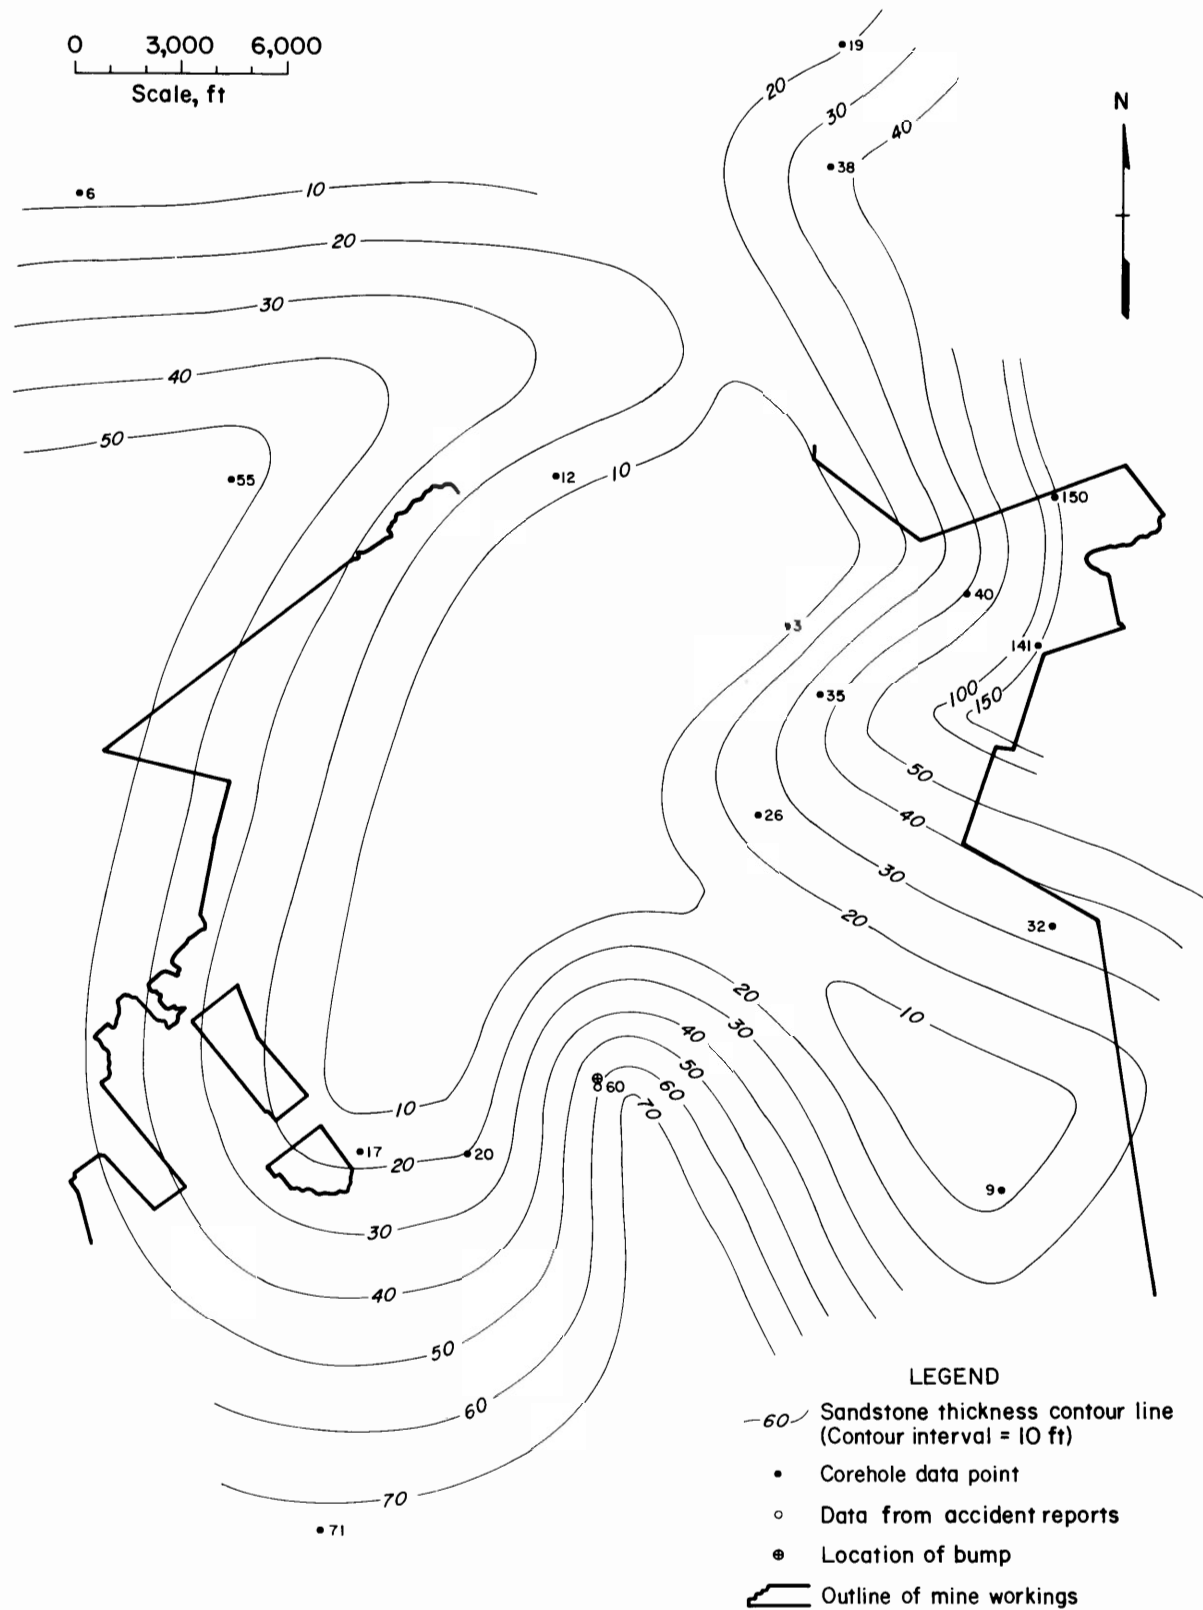
Figure 7.—Sandstone thickness map of Eckman Sandstone, which immediately overlies Pocahontas No. 4 Coalbed, mine 1.

is present through the central portion of the mine area (fig. 7), whereas thicker sandstone accumulations are preserved in the northeast and southwest corners. The variable nature of the thickness of this sandstone unit is most likely the result of the confinement of sand deposition to channels. The mine contains numerous straight, but digitate coal washouts.

On October 18, 1983, two miners were killed by a bump accident on a continuous miner section, located as marked on figures 7 through 9. No deviations from the general structural trend were evident in the area (fig. 7). Therefore, unusual structural conditions did not lead to the occurrence of the bump. Overburden thickness was in excess of 900 ft (fig. 9). Additionally, data from a Mine Safety and Health Administration (MSHA) accident report (5) and in-mine observations indicated that a hard sandstone approximately 60 ft thick was present immediately above the coalbed (fig. 7). The bump occurred during the mining of the 140- by 350-ft No. 3 barrier pillar. Figure 10 illustrates the conditions directly after the accident. Eight entries on 39-ft centers were planned to divide the pillar. Forces from the bump moved the continuous miner against the right rib and the shuttle car into the crosscut between entries 5 and 6 (fig. 10). The left rib in the No. 5 entry was displaced approximately 8 ft and coal filled the rest of the entry to a depth of 42 in for a distance of approximately 86 ft. The displaced coal is indicated by a dashed line on figure 10. The roof bolting machine was not moved by the forces; however, coal was expelled, filling the No. 2 entry with coal from 3.5 to 5 ft deep, for a distance of 60 ft (5).

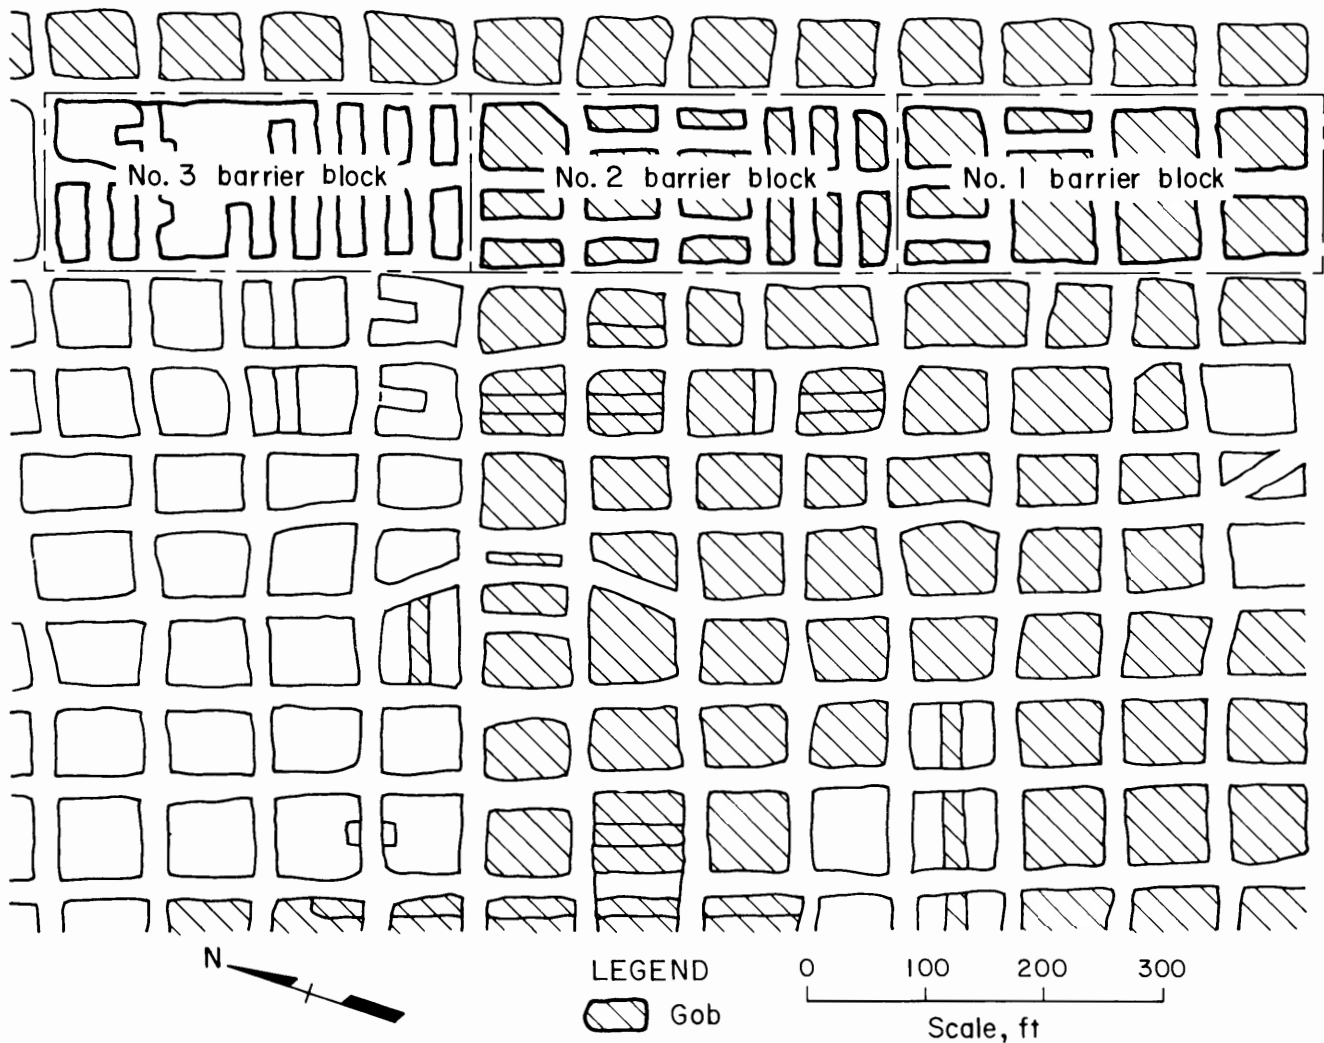
Figure 11.—Plan view of mining sequence prior to bump accident, mine 1.

It should be noted that the pillar geometry of this section was set many years prior to retreat mining. The condition of this area (roof falls especially) often caused changes to be made to the mining plan.

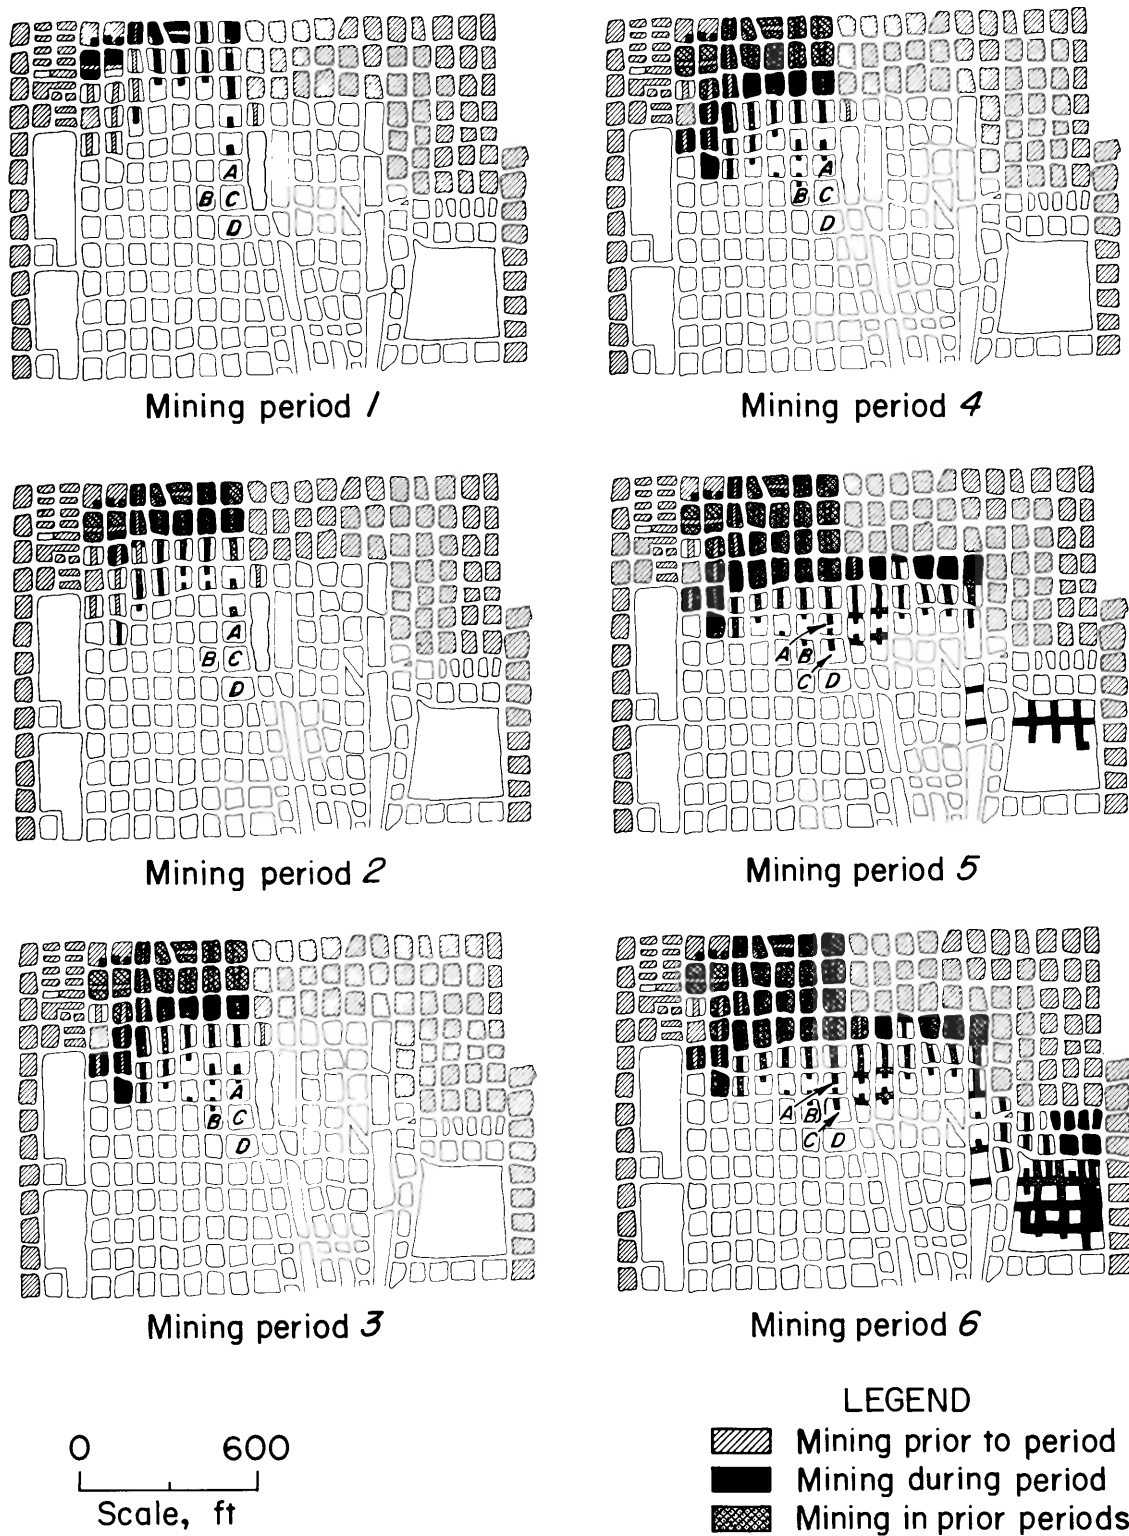
Figure 14.—Progress of mining maps, for mining periods 1 through 6, of hydraulic load cell readings, mine 1.

did not take place in pillar D until mining period 5 (fig. 14). At that time pillar C was split halfway and bump cuts were made in a pillar adjacent to pillar A. Second, the cells load evenly up to the point of periphery yield and confined core loading. This phenomenon is verified by all cells except for the data from pillar B. Finally, all four pillars demonstrated an increase in core loadings upon periphery yield.

The reduction in pillar load-bearing capacity must be carefully controlled or a squeeze may result. Roof-to-floor convergence of as much as 3 ft has occurred, which forces the taking of the floor. The pillar splitting for stress relief illustrated by figure 14 requires a significant increase in equipment travel distance as opposed to conventional room-and-pillar retreat. Mining must be conducted simultaneously in locations as much as 400 ft apart. At this mine, the mining sequence is determined on a case-by-case basis.

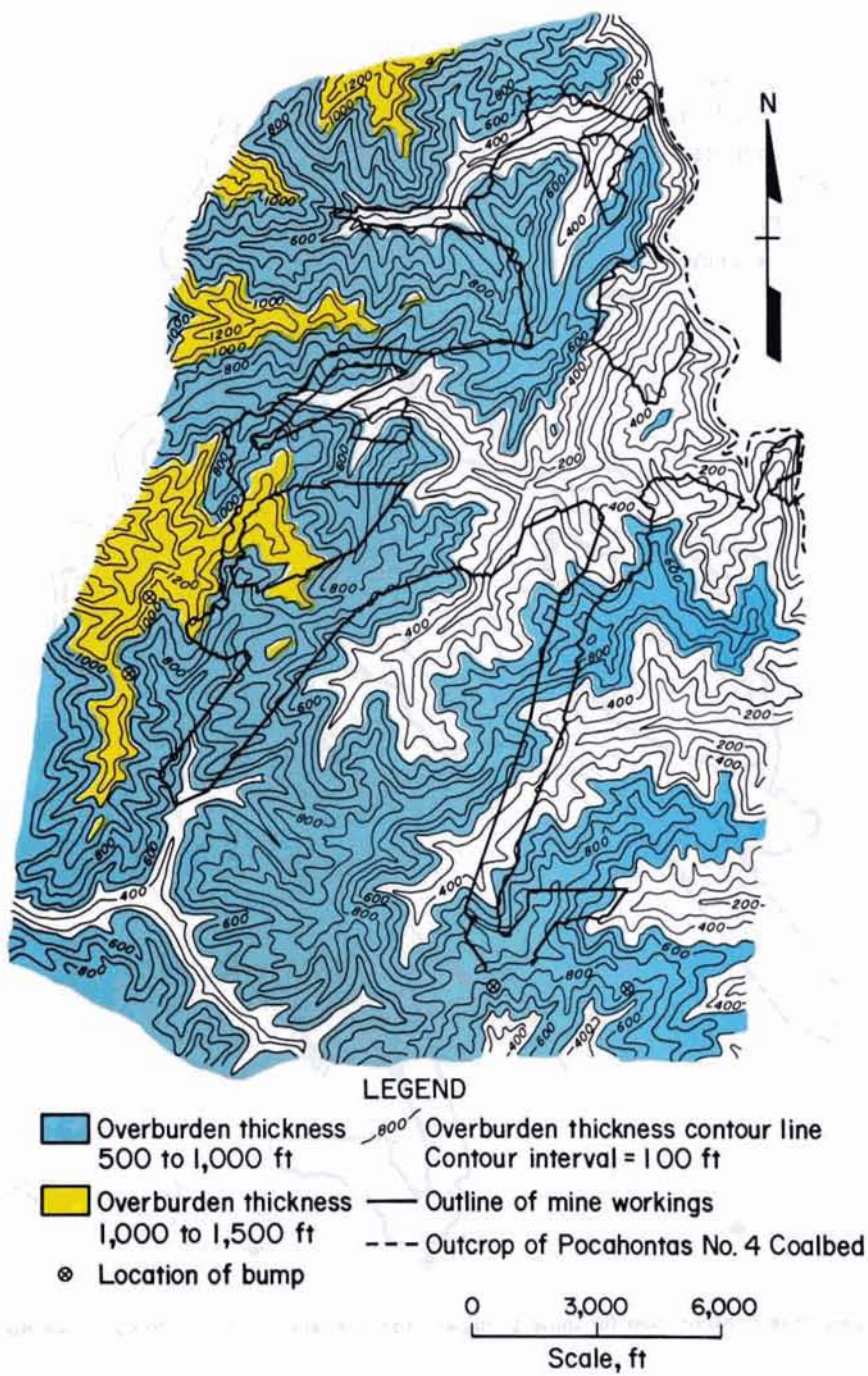
Figure 19.—Overburden map for mine 2.

Overburden thicknesses at mine 2 are less extreme than those at mine 1. The Pocahontas No. 4 Coalbed crops out along Tug Fork where several portals lead into mine 2 toward the west. Highest overburden thicknesses are attained in the west-central portion of the mine (fig. 19). Two major bumps have been documented from this area;

both occurred in areas with greater than 1,000 ft of cover. Two other bumps were experienced under 700 to 800 ft of strata (fig. 19). Mine personnel indicate that no bumps have been recorded under creekbeds, plausibly as a result of lower overburden thicknesses in such areas. Additionally, mine personnel note that where surface fractures have been recognized just off the crests of mountains on the mine property, there have been no bumps in the mine below. Mine personnel believe that these fractures may extend to a depth of 200 ft and theorize that they may relieve some of the stresses imposed by greater overburden thicknesses.

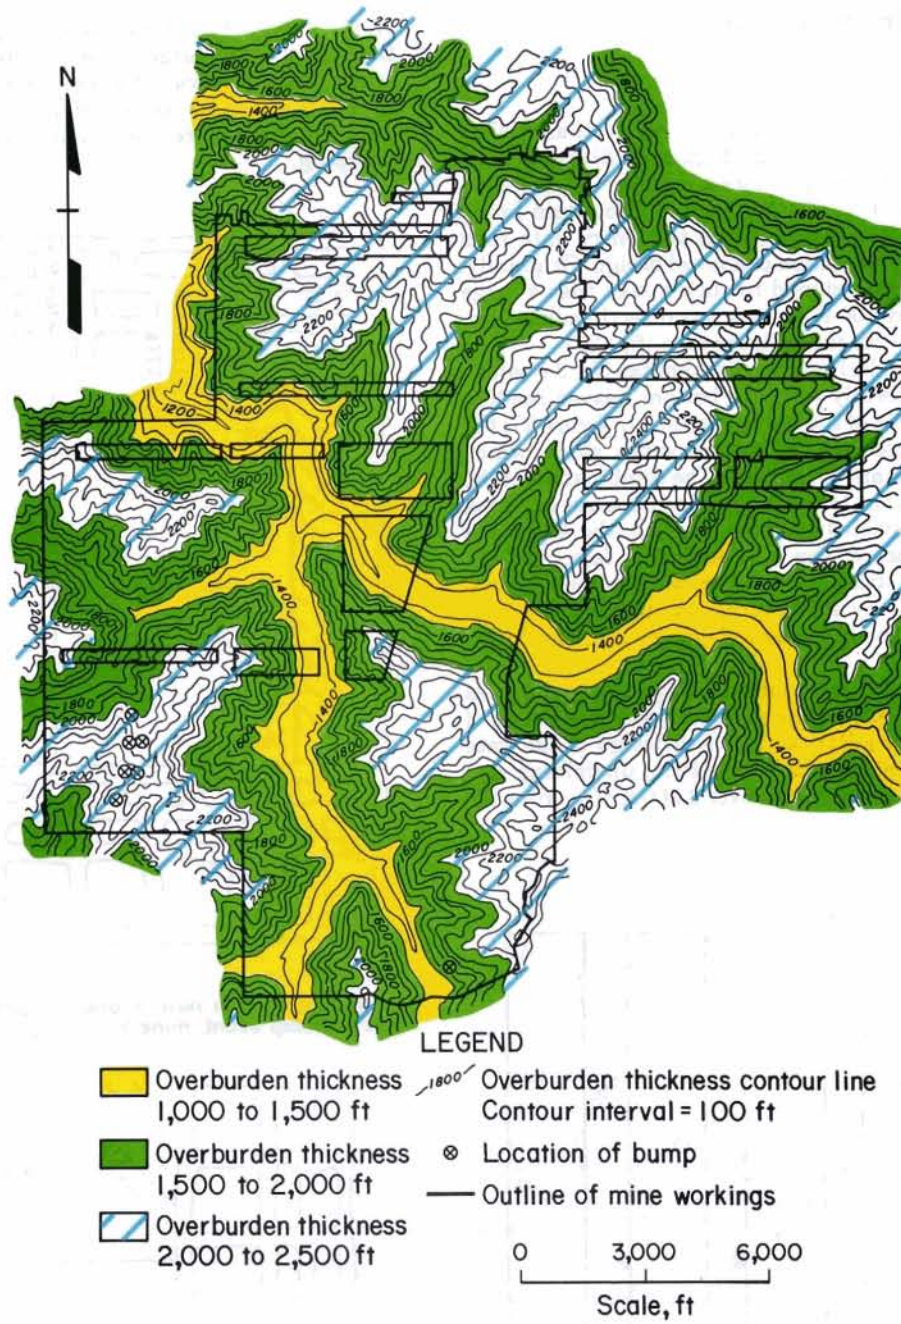
Figure 25.—Overburden map for mine 3.

Overburden thicknesses at mine 3 are extreme; this mine is the deepest of the five examined in this study. Depth of cover ranges from just under 1,200 ft to in excess of 2,400 ft (fig. 25). Bumps have been noted to occur at various depths throughout the mine, but, according to mine personnel, the majority of bumps are experienced under greater than 2,200 ft of overburden. The locations of several previous bump occurrences are indicated on figure 25. All but one of these bumps took place under more than 2,200 ft of cover.

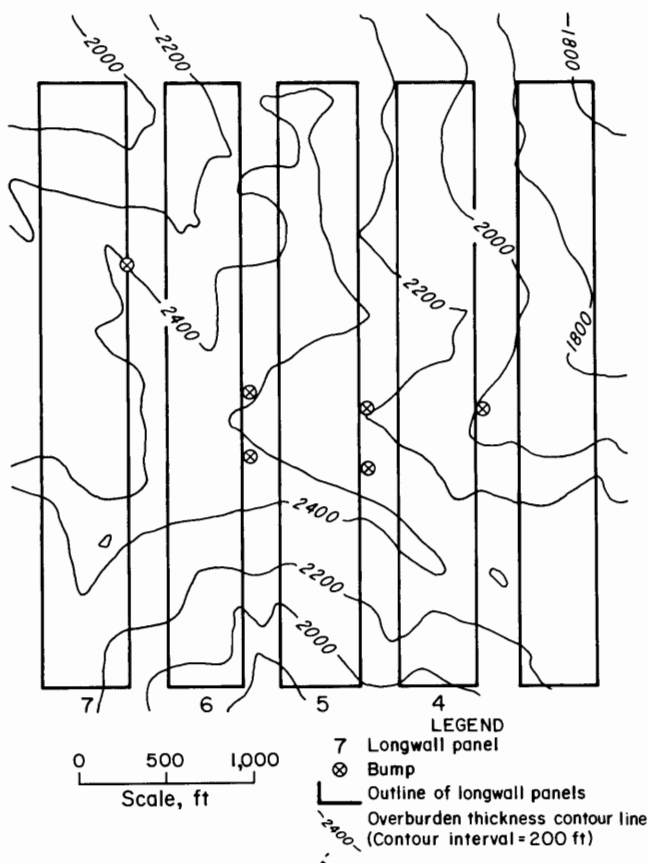
Figure 26.—Locations of retreating longwall bump events and overburden thicknesses, mine 3.

Mine 3 has experienced bumps on longwall as well as room-and-pillar retreat workings. Figure 26 (8) displays the location of six retreating longwall bump events that occurred from March 1972 to May 1974. Mountain bump occurrences were minimized in the tail entry gate road pillars by the implementation of a novel design. Originally, the gate roads were designed in such a way that a large block cut on 100- by 100-ft centers was directly adjacent to the longwall panel on the tailgate side (fig. 27).

Two steps were taken by mine management to prevent further bump hazards: (1) the softening, via shot firing of the large tail entry pillar, and (2) a redesign of the gate roads for subsequent panels. Where firm, unyielding roof and floor strata are present with over 2,200 ft of overburden

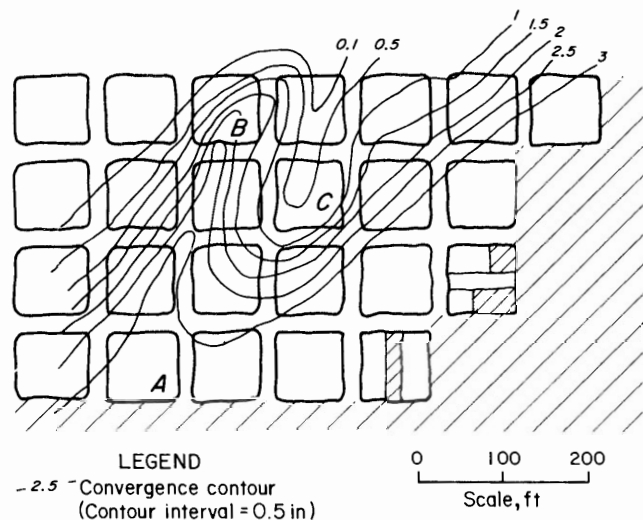
Figure 30.—Convergence contour map for room-and-pillar retreat mining, mine 3.

As stated earlier, the gradual yielding of pillars near the pillar line is necessary to avoid the energy storage in the pillar core, which leads to pressure bumps. Without a better measurement method, it is assumed that roof-to-floor convergence may indicate the extent of pillar yield. Figure 30 displays the convergence contours outby the pillar line. Note the 2- to 3-in total convergence along the line from pillar A to B and the 0.5- to 1.5-in total at pillar C. Pillar C was later water infused to enhance pillar yielding.

The water infusion of pillar C was accomplished by pumping water at 800- to 1,200-psi pressure, into the pillar at a rate of 10 gal/min. Figure 31 shows the effect on the convergence rate around the infused pillar. The dramatic increase in the convergence rate caused by the water infusion led mine officials to assume that the pillar was distressed. It was then mined without incident. The same test was performed on other pillars. The increases in convergence rate were not as pronounced, but the pillars were mined without incident. Water infusion is not presently conducted for bump control at mine 3.

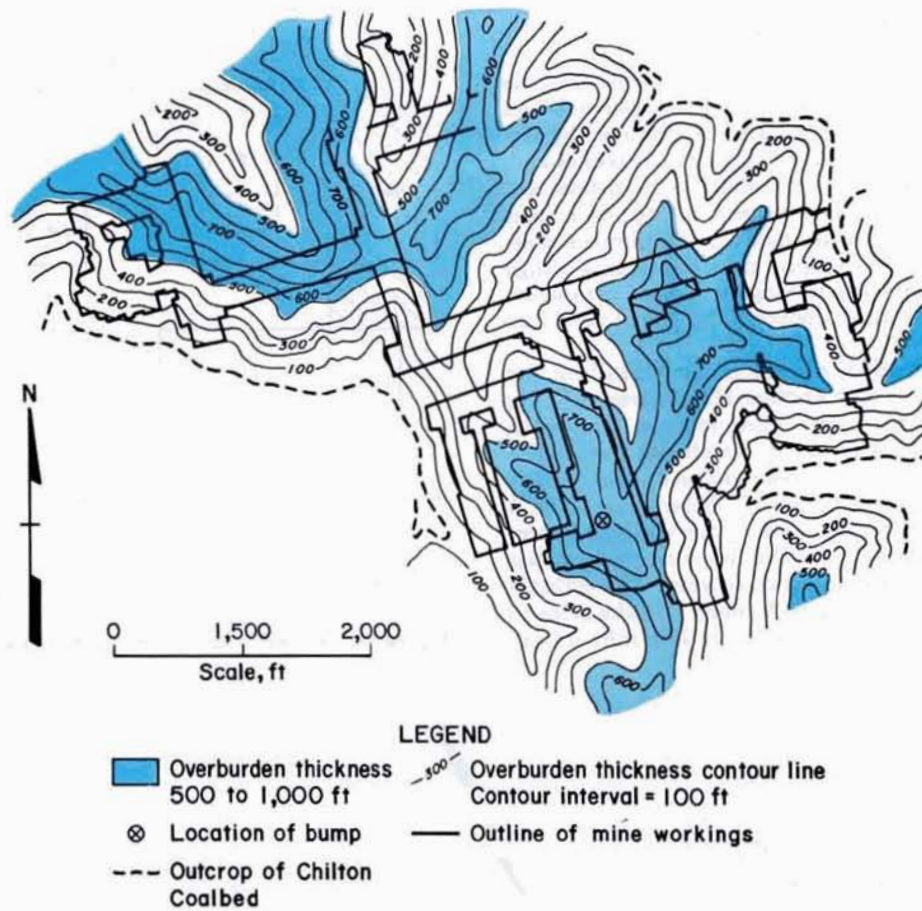
Figure 35.—Overburden map for mine 4.

In comparison with other mines examined in this study, overburden depths at mine 4 are relatively shallow (fig. 35). The mine is outlined, for the most part, by the outcrop of the Chilton Coalbed. Only under the hilltops does the overburden thickness increase to over 700 ft. A fatal bump occurred in one of these areas of maximum overburden thickness (fig. 35).

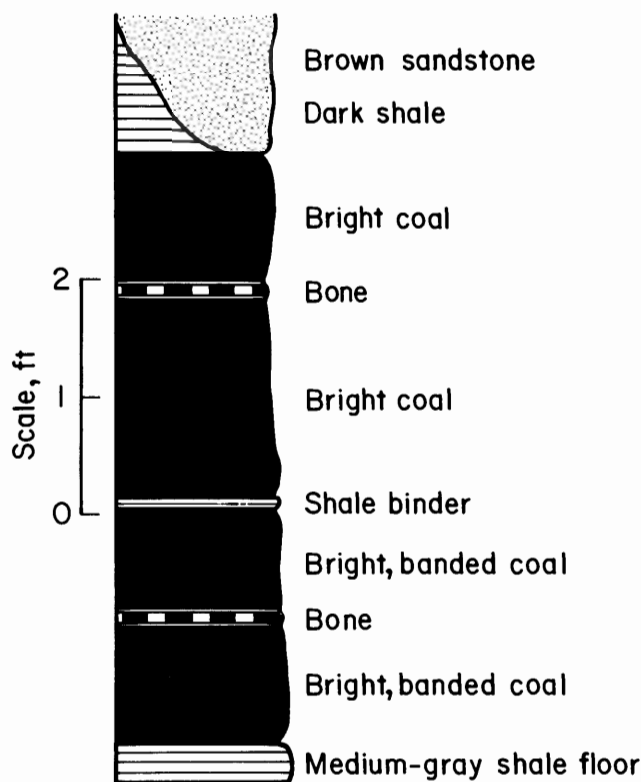
southeastward of Campbell Creek, Kanawha County (12). Throughout the mine, the No. 2 Gas Coalbed is 43 to 63 in thick. The coalbed is friable and displays multiple benches, each separated by binders of bone or shale (fig. 39). A persistent bone binder, noted at several locations in the mine, occurs approximately 1 ft from the top of the coalbed. A thicker, more prominent and continuous bone layer is also found approximately 1 ft above the bottom of the coalbed. Mine personnel believe that this binder stores energy from overburden pressure. Therefore, they recommend the removal of the lower parting first when mining commences.

Figure 39.—Generalized stratigraphic column for mine 5.

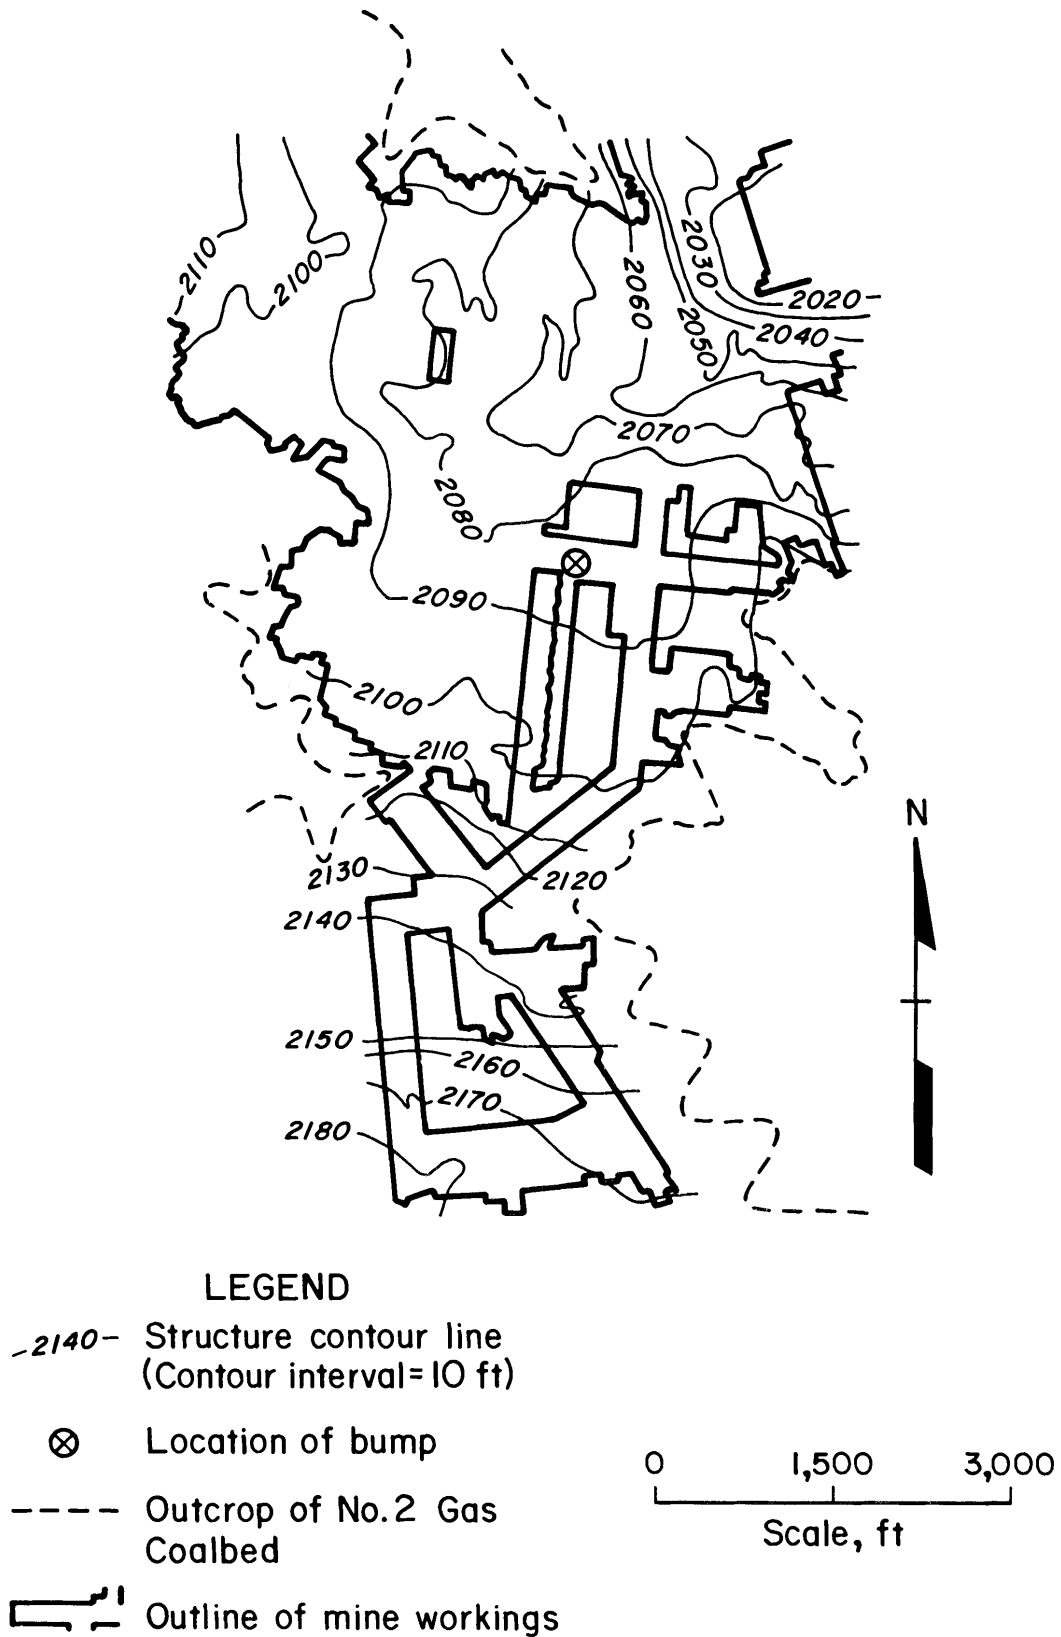
of the axis of the Handley syncline. The No. 2 Gas Coalbed dips at  $1^{\circ}$  to  $1.5^{\circ}$  to the northwest toward the axis of this syncline (fig. 40). No faults or clastic dikes have been observed in the mine. A few kettlebottoms are present where the shale intervenes between the coalbed and the overlying sandstone.

Figure 40.—Structure contour map for mine 5, drawn from elevation of top of No. 2 Gas Coalbed.

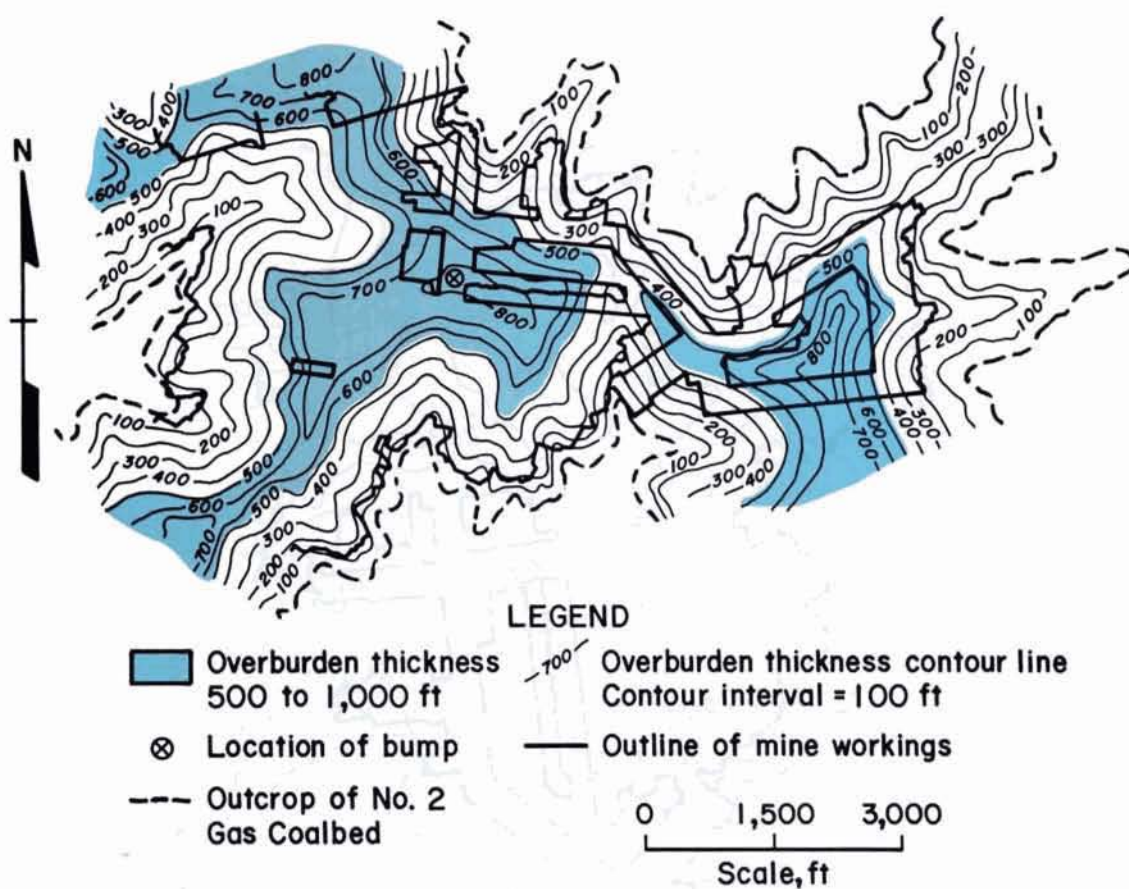
Overburden intervals at mine 5 are relatively thin when compared with overburdens of the other mines examined in this study. A large portion of the mine is outlined by the outcrop of the No. 2 Gas Coalbed. As at mine 4, the thickest overburden is present under hilltops on the mine property. In those areas, the coalbed may be much as 850 ft deep (fig. 41). Large surface cracks have been observed above the coalbed on these mountains. The bump that occurred in this mine on February 10, 1984, was located in the deepest portion of the mine, under more than 800 ft of cover (fig. 41).

Figure 41.—Overburden map for mine 5.
